# FINAL 2008 INTEGRITY AND HYDROSTATIC TESTING REPORT (CDRL A001) OF JP-8 AND GROUND FUELS PIPING

KIRTLAND AFB, NM

# FINAL 2008 BIENNIAL INTEGRITY AND FIVE YEAR HYDROSTATIC TESTING REPORT (CDRL A001) OF THE PETROLEUM OIL AND LUBRICANT (POL) FUEL PIPELINES

#### KIRTLAND AFB, ALBUQUERQUE, NEW MEXICO

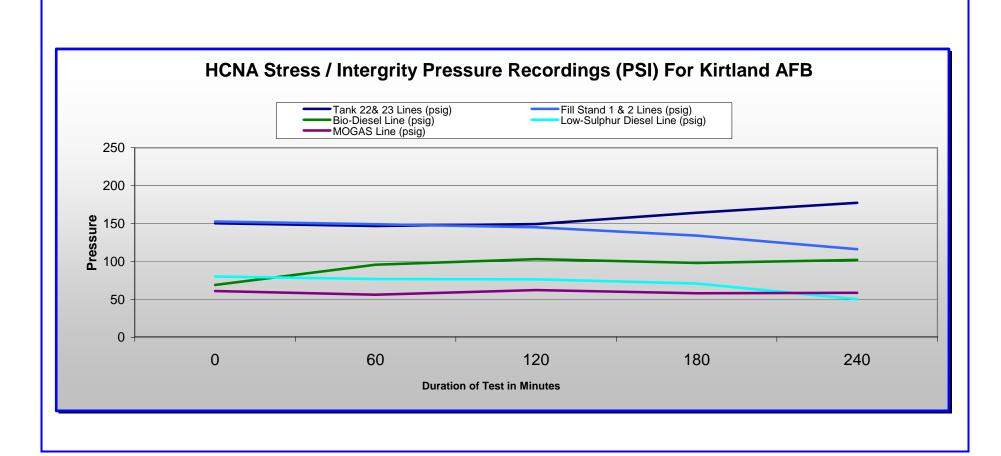
Hansa Consult North America (HCNA) LLC Pressure Test Results
Tests Conducted November 5,6, and 10 2008
